# A Rare Complication of Arthroplasty: Metallosis

Cansu Benli Işık, Halide Nur Ürer\*, Saime Gül Barut, Mustafa Fehmi Akyıldız\*\*, Doğan Atlıhan\*\*

University of Health Sciences Haseki Training and Research Hospital, Clinic of Pathology, İstanbul, Turkey

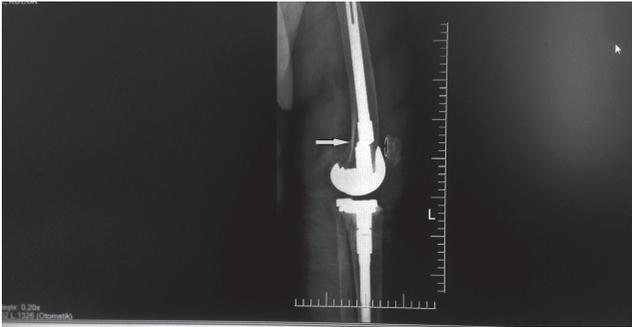
**Figure 1.** The fracture in the femoral component before the operation

breaking of the tibial polyethylene insert and a fracture in the tibial and femoral components. The prostheses were removed and the joint was debrided. The femoral component and tibial base plate were placed and the operation was completed.

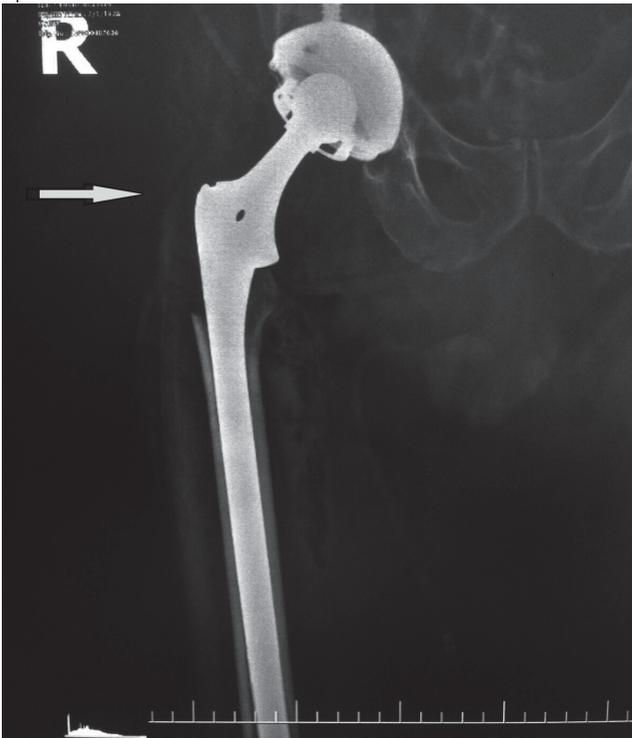
**Figure 2.** Osteolysis in the proximal femoral component

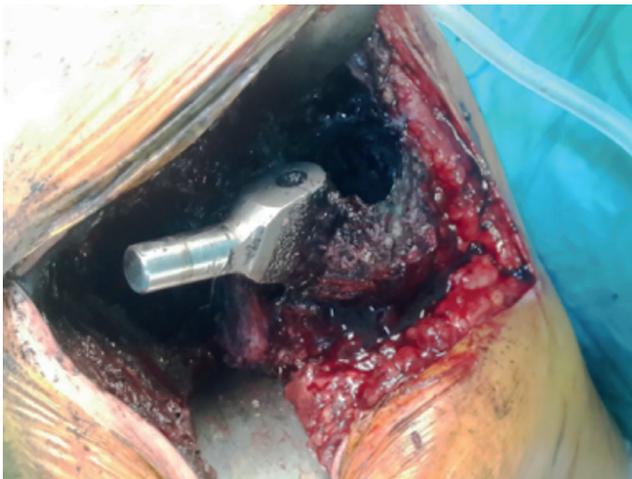
**Figure 3.** Diffuse color change to black in the soft tissue surrounding the joint, during the operation

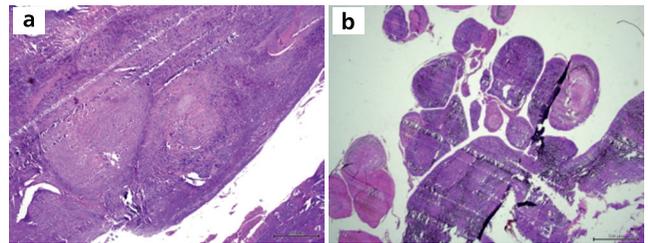
Microscopic examination showed a structure consisting of broad nodular and papillary extensions (Figure 4a, 4b). Widespread black pigmentation (Figure 5) was observed in the extracellular and multinuclear giant cells on the fibrotic background that seemed rich by cells, as well as occasional foam-like cytoplasmic histiocyte accumulations and lymphocytes (Figure 6). Fibrosis-surrounded necrotic

**Figure 4.** Broad nodular and papillary extensions

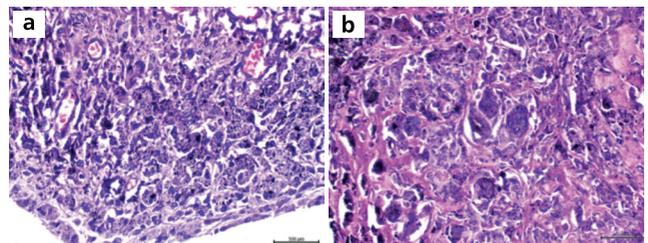
**Figure 5.** Presence of the black pigment in the multinuclear giant cells and extracellular region

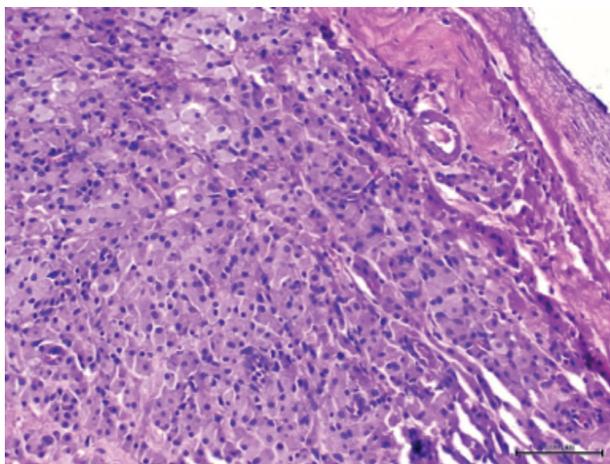
**Figure 6.** Accumulation of foamy cytoplasmic histiocytes

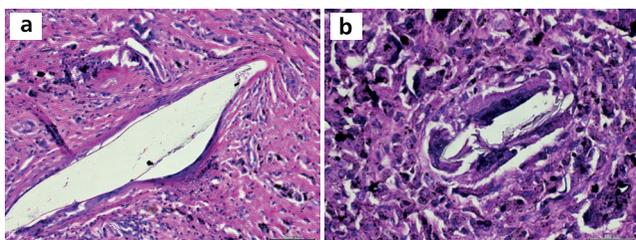
nodules were found in rare occasions. Additionally, refractile crystalloid fragments were seen in some multinuclear giant cell cytoplasm in our first case (Figure 7).

**Figure 7.** Refractile crystalloid fragments in some multinuclear giant cell cytoplasm
